# Manhole Inspection Summary

Manhole # S11II1020MH

Insp Date: **5/24/07 9:51 AM**

**Location** Address: **4503 WYLIE AVE**

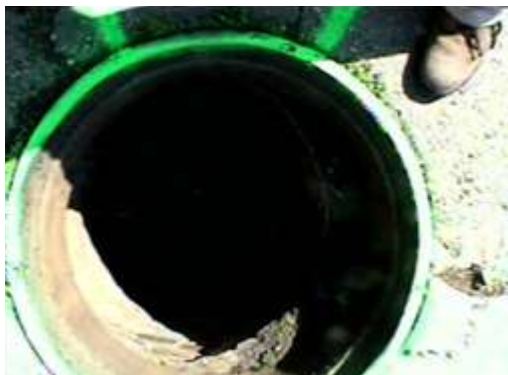
Defect 2

Offset: **4** (in.)

FRAME OFFSET

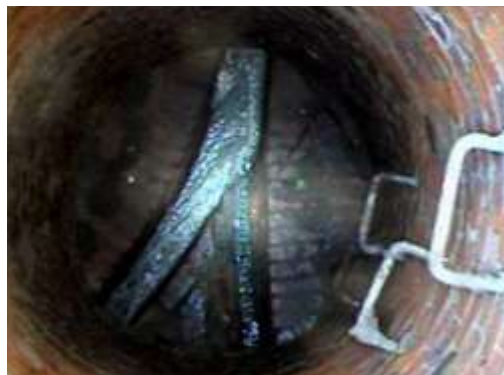
Defect 1

Count: **5** Missing: **0** ☒ **Corroded**

CORRODED STEPS

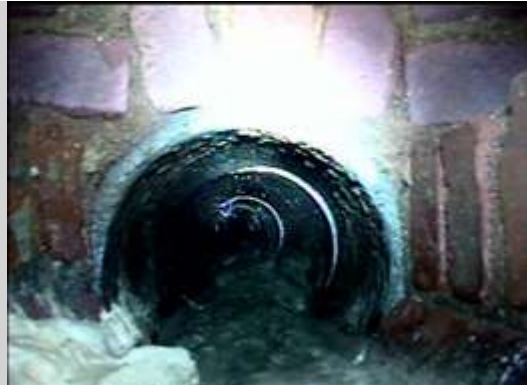
12 O'Clock Outflow

8 in. Circular Gravity Sewer  
Pipe Out @ 12 O'Clock

Pipe Height: **9.6** (in.) Rod and Bar (Angled)  
Pipe Material: **Clay** ☐ Pipe Lined  
Invert Depth: **10.95** (ft.) Flow Characteristics: **Slow**  
Deposits: ☒ None ☐ Mud ☐ Sludge ☐ Debris ☐ Grease  
Silt Depth: (in.) Deposits Extent:  
Infiltration: **None** Pipe Seal Cond: **Sound**

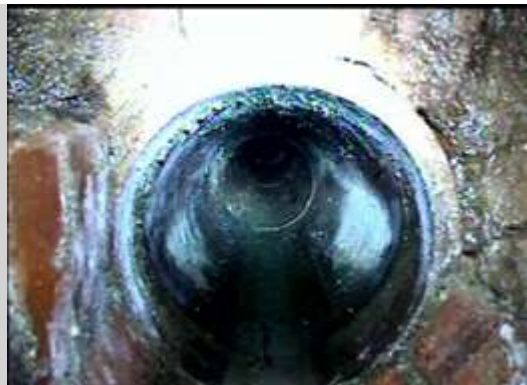
6 O'Clock Inflow

8 in. Circular Gravity Sewer  
Pipe In @ 6 O'Clock

Pipe Height: **9.6** (in.) Rod and Bar (Angled)  
Pipe Material: **Clay** ☐ Pipe Lined  
Invert Depth: **10.09** (ft.) Flow Characteristics: **Slow**  
Deposits: ☒ None ☐ Mud ☐ Sludge ☐ Debris ☐ Grease  
Silt Depth: (in.) Deposits Extent:  
Infiltration: **None** Pipe Seal Cond: **Cracked**

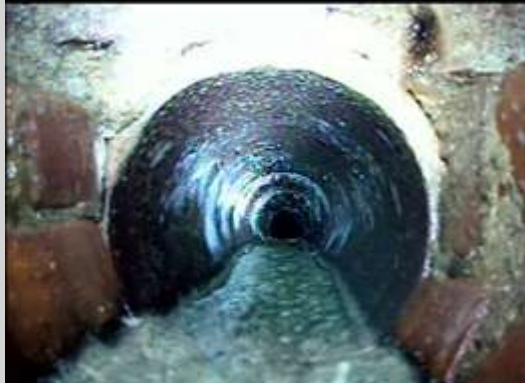
7 O'Clock Inflow

8 in. Circular Gravity Sewer  
Pipe In @ 7 O'Clock

Infiltration: **None** Pipe Seal Cond: **Cracked**
